312 9th Avenue North

ARC #3

Date: February 11, 2022

GRAPHITE

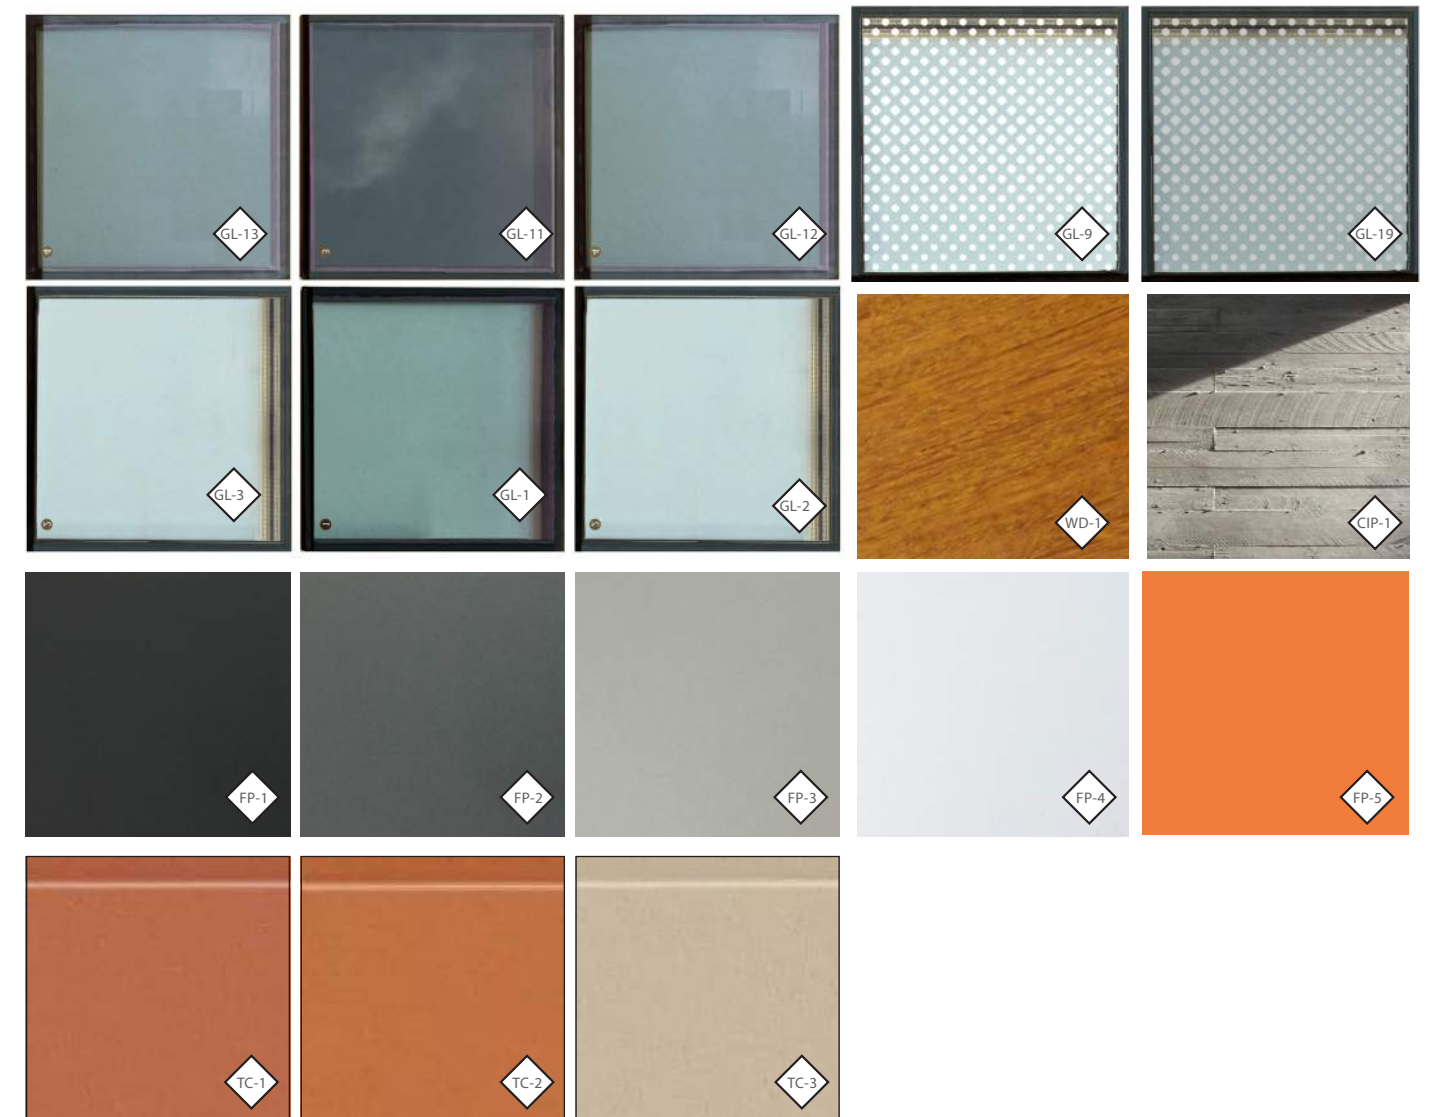
| Tower Vision Glass | Fritted Accent Glass | Metal Panel | Yellow |
